**Atmospheric Infrared Sounder**

# AIRS and Aqua Mission Operations Status and New AIRS On-board Gain Table

**Denis Elliott**

**November 11, 2011**

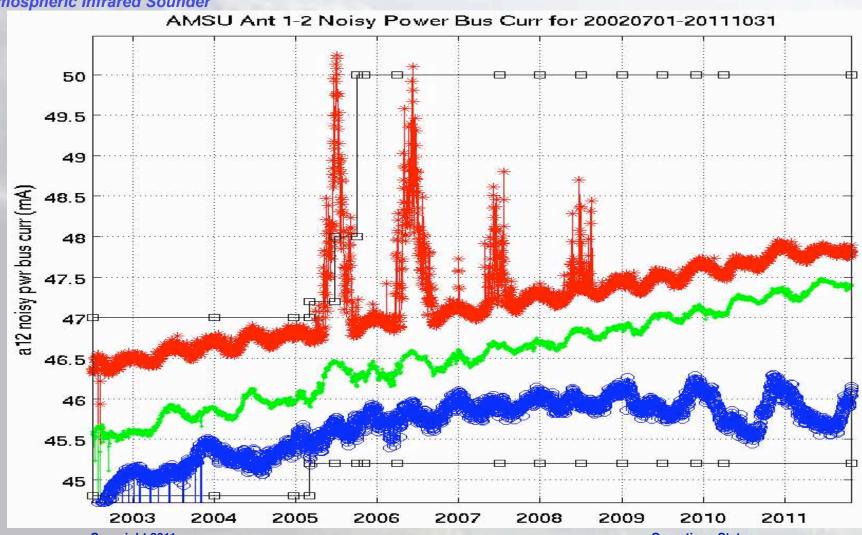
# **AMSU-A1-2 Noisy Bus Current**

- AMSU-A1-2 noisy bus current
  - For a period of a few months (centered on the southern hemisphere winter solstice) in 2005, 2006, 2007, and 2008 noisy bus currents rose near the south pole and returned to normal when the spacecraft was not near the pole
  - The problem has been attributed to increased friction in the scanner related to cold temperatures
  - The currents never came close to the yellow limit

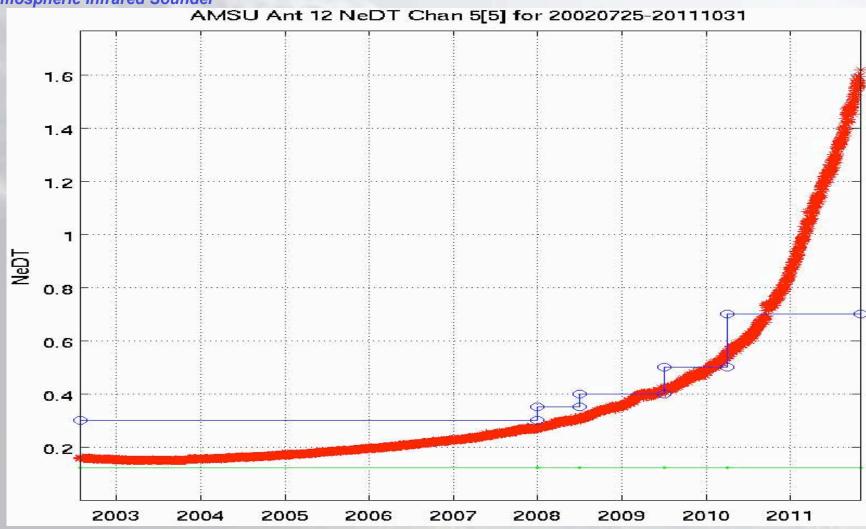
#### **AMSU-A Channel 5 ΝΕΔΤ**

- AMSU-A mechanical parts and most of the electronics are in very good health
- Engineering parameter trends are slow—no concerns
- 12 of the 15 channels are rock solid, but
  - Channel 4 failed in 2007 (declared non-operational on October 1 2007)
  - Channel 5 continues to degrade
  - Channel 7 noise has exceeded specs since launch and has never been used for L2

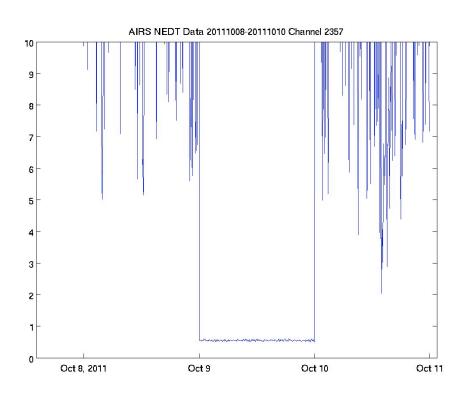
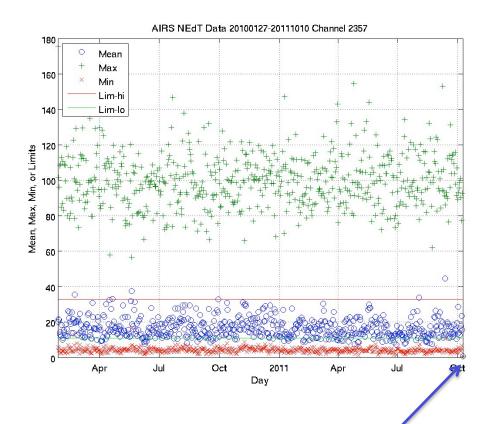
# Obvious improvement – Channel 2357, A+B->A

Result: noise changed from >10 K to under 1K.

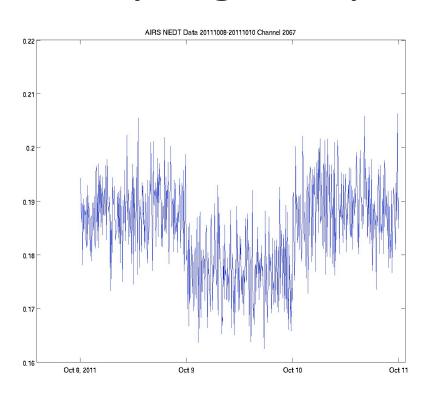
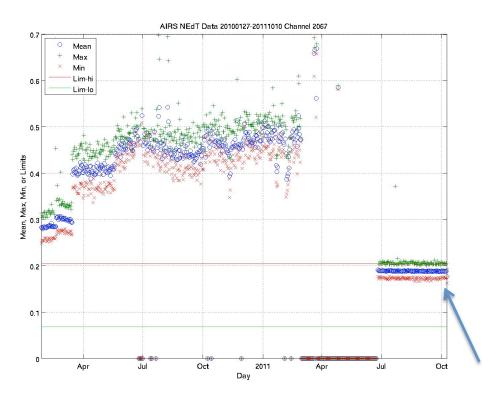
## Very slight improvement – Ch 2067

A+B->A. Channel appears to have recovered, but it is not apparent in C2 B data. A side has been stable throughout.

Rationale: improve stability

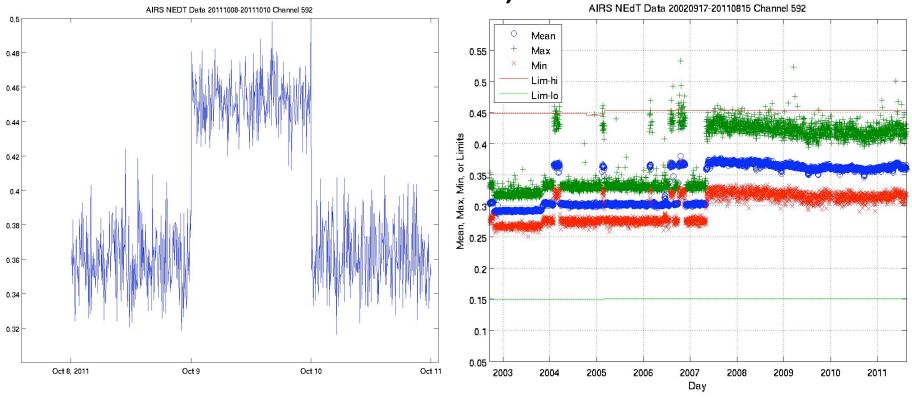
# Slightly worse Channel 592, A+B -> B

## 2 states, A non-Gaussian

Result: NEDT 0.36 -> 0.45, no apparent improvement in stability.

Rationale: improve stability

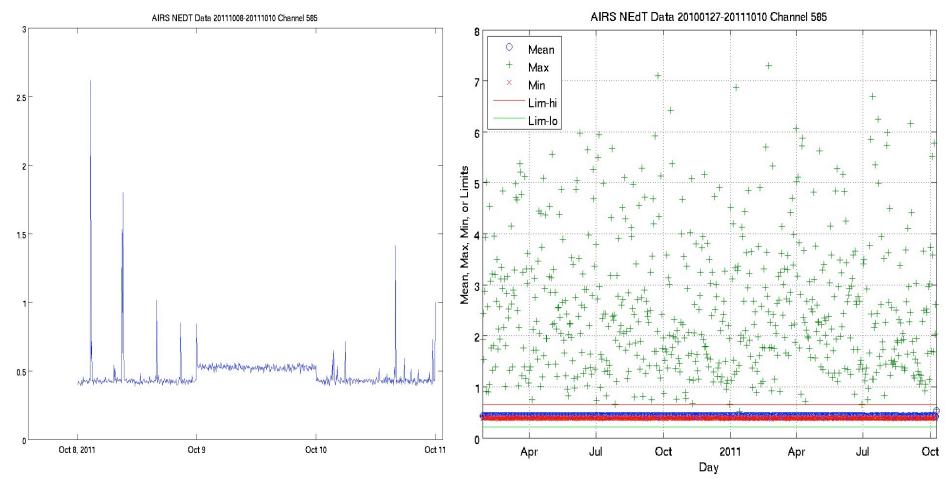
## Channel 585, A -> B

A has CSN, try B to see if no CSN.

**Rationale: eliminate CSN**
